Manhole Inspection Summary

Manhole # S05YY_024MH

Insp Date: **7/16/07 2:09 PM**

Location Address: **3801 GARRISON BLVD**

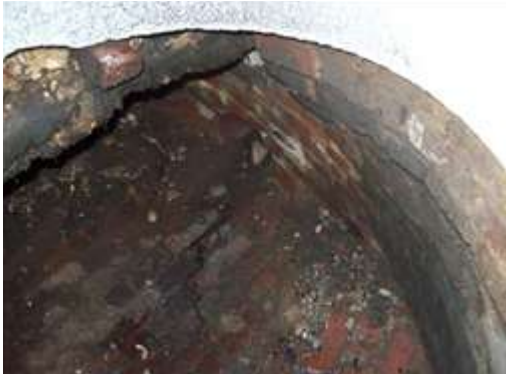
Defect 1

Condition: ☐ Sound ☐ Cracked ☐ Root Intrusion ☐ Loose Brick ☒ **Deteriorated**

DETERIORATED CORBEL

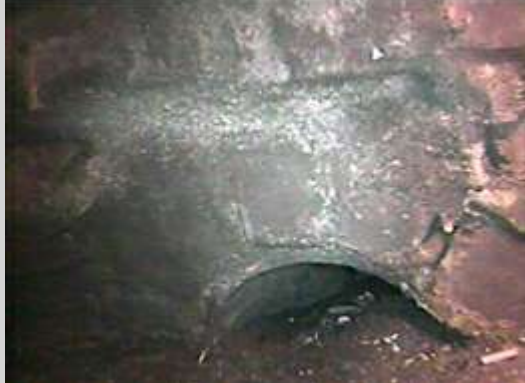
12 O'Clock Outflow

8 in. Circular Gravity Sewer
Pipe Out @ 12 O'Clock

Deposits: ☐ None ☒ **Mud** ☐ Sludge ☒ **Debris** ☐ Grease

Silt Depth: **6** (in.) Deposits Extent: **Heavy**

Infiltration: **None** Pipe Seal Cond: **Cracked**
